Yamhill-Carlton School District

Building Assessment

Yamhill Carlton Intermediate School

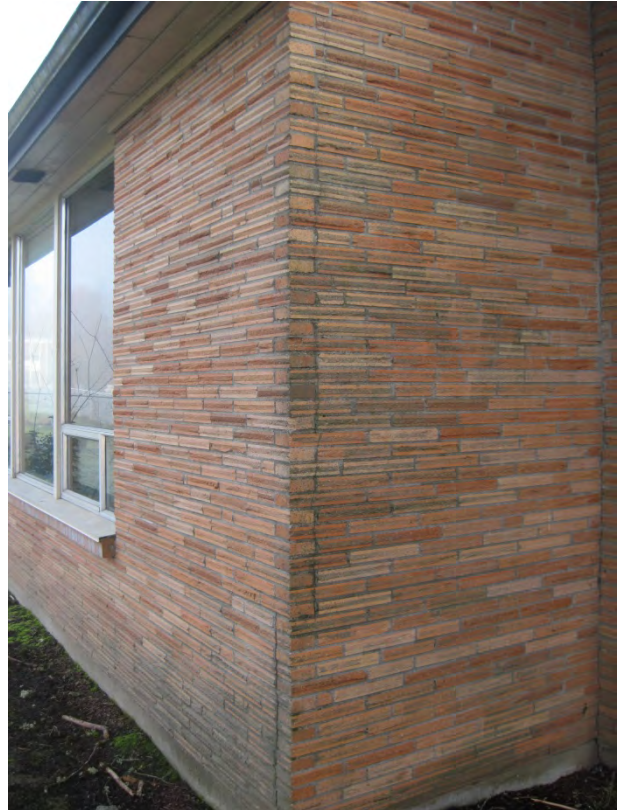
The brick veneer has two primary areas of concern need for tuckpointing of mortar joints and installation of a good quality water repellant anti-graffiti guard. The pictures below show cracking of brick and mortar. These areas unprotected overtime will allow moisture to penetrate into the wall system promoting mold, mildew, and potential dry rot. Tuckpointing will remove the cracked and missing mortar. Installation of water repellant will seal the brick stopping water penetration.

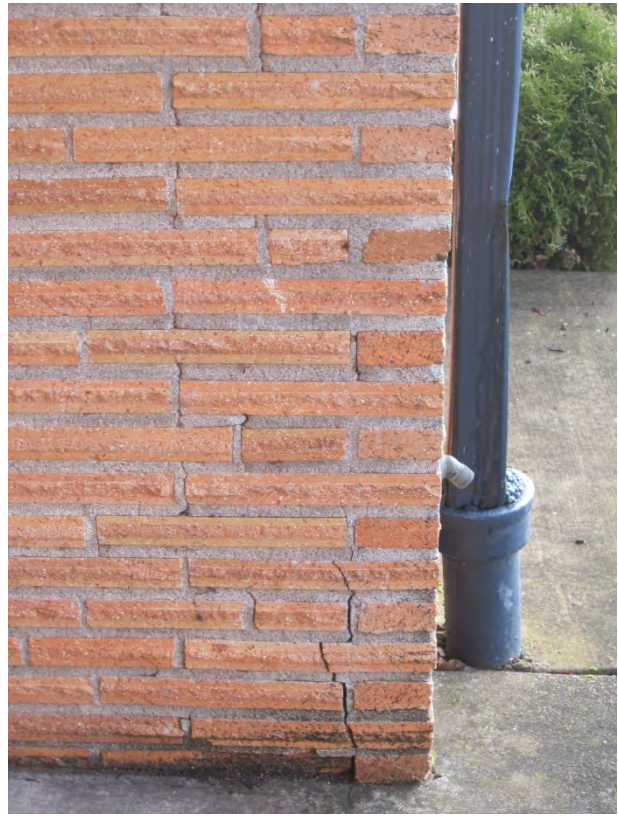
Both of these pictures on the west side of the school show areas of mortar cracking. Cracking was observed at the inside corner and both faces of the outside corner. These types of areas especially on the prevailing weather side of the building are concern for water penetration.

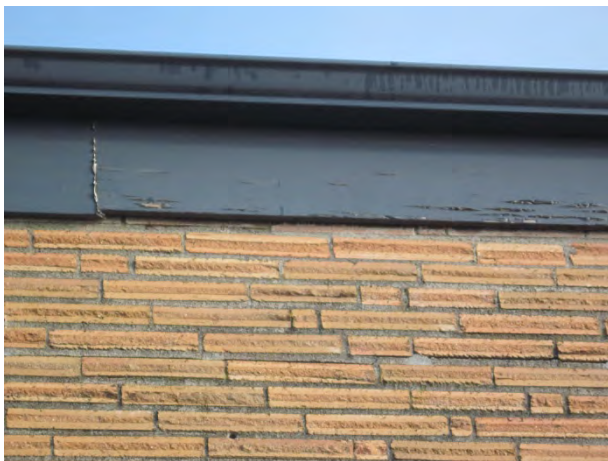
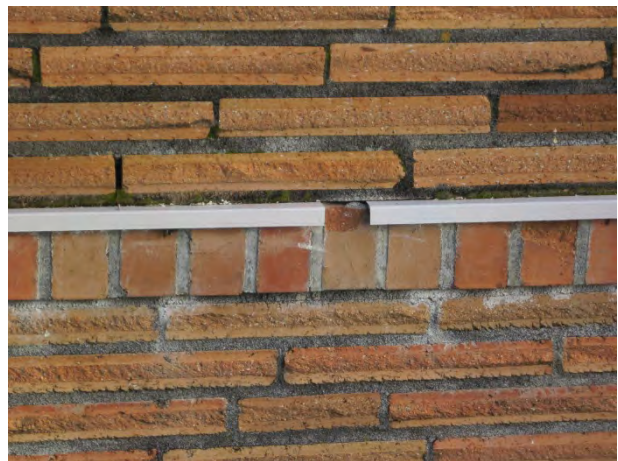
Both of these pictures depict mortar cracking. I also suspect that over prolonged periods due to freeze thaw conditions mortar is actually degrading opening larger gaps 1/4" and larger. The picture to the left is on the west side of the building. The picture to the right is at the Westerly entry on the south side of the building.

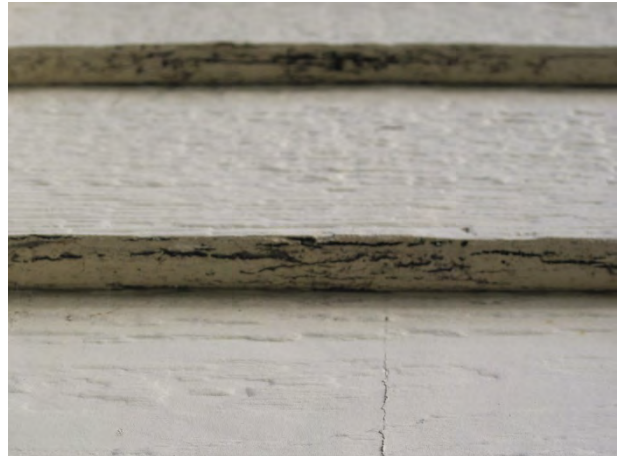
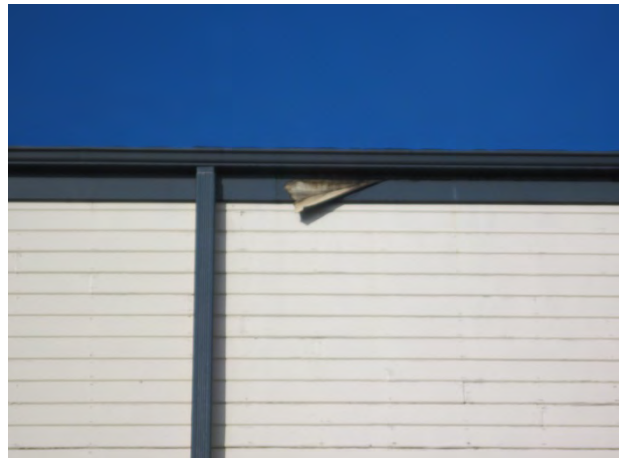
On the South Side of the building as well as on the gym, we observed what appears to be LP Lap Siding. The siding is showing signs of delamination. The district should replace all LP Siding immediately. If funds are not available for immediate replacement the district could apply Elastomeric coating to all exposed edges and surfaces, providing the district with 5 years additional life until the replacement could be budgeted.

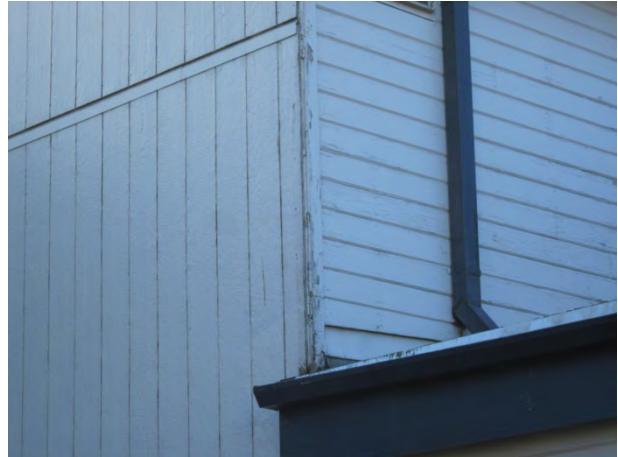
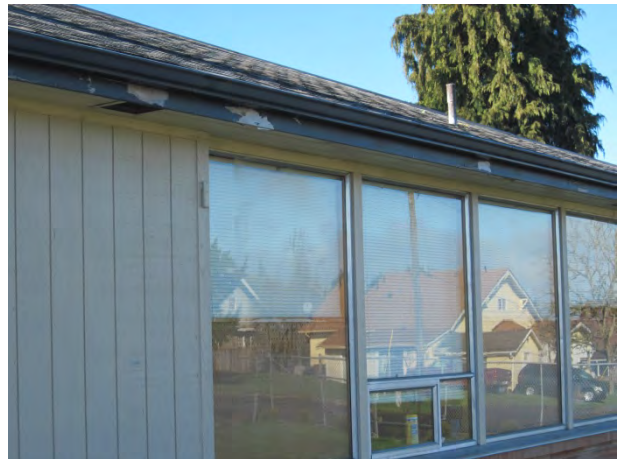
Another area needing attention is exterior paint of all wood siding, trim, and doors. Many areas have peeling paint, missing caulking, and raw wood exposed to the weather. Prolonged exposure of the exterior wood surfaces to the weather will experience dry rot. You will note some of the pictures in this report show various forms of paint degradation. We recommend that the entire building, all wood surfaces, doors, and trim receive paint.

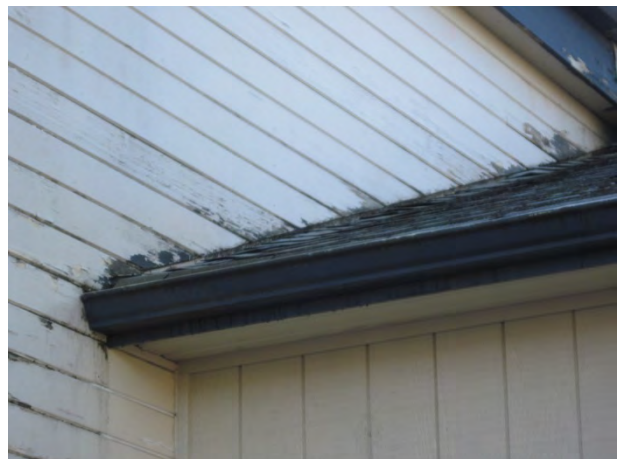
These pictures depict the exterior siding and trim degradation observed around the building.

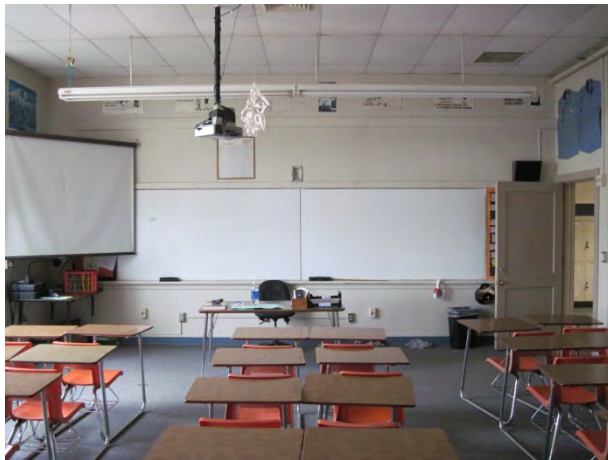
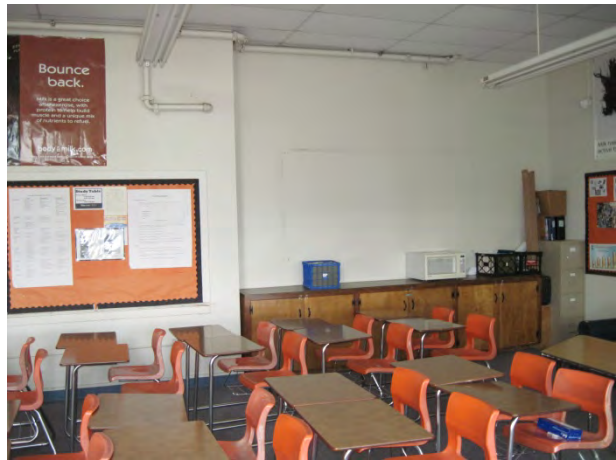
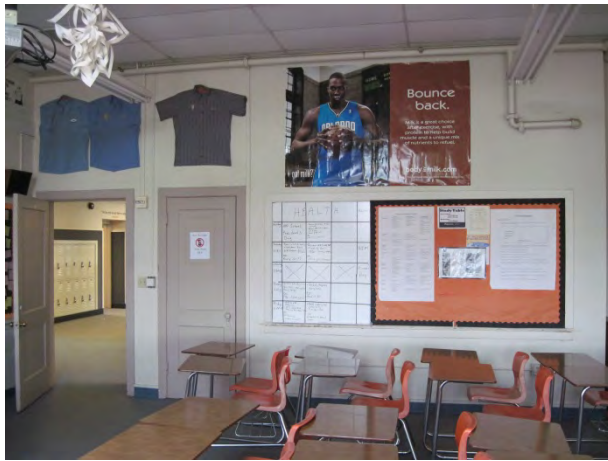
Basement and main floor classrooms do not have adequate storage. Marker boards are inadequate with the porcelain writing surface nearing end of life. Many rooms do not have bulletin boards or have surfaces not made for pinning display materials; teachers use creative ways to display items even when pinnable surfaces are not available. (Pictures below are of room 206)

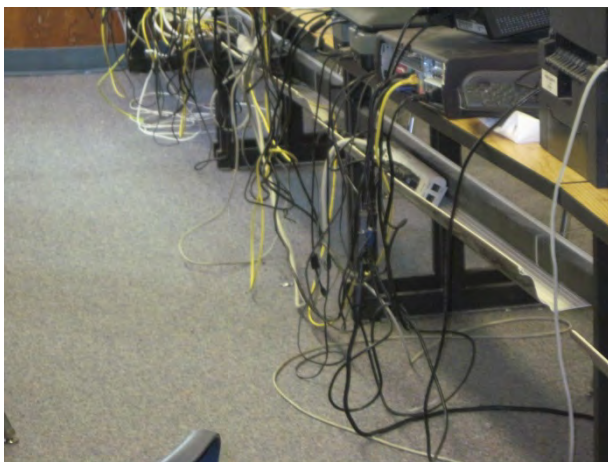
Computer labs are converted classrooms. The labs in basement and on the main floor could use improvements to power, data, and cooling upgrades to better accommodate the educational program served. Power and data cords are potential trip hazards.

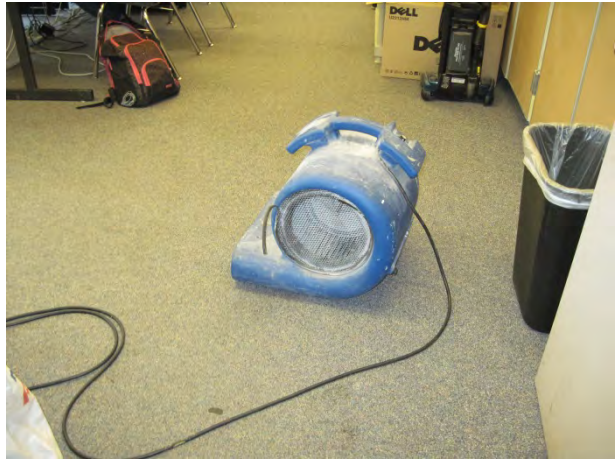
Comfort in the basement computer lab is poor, excessively hot needing additional fans to provide air movement

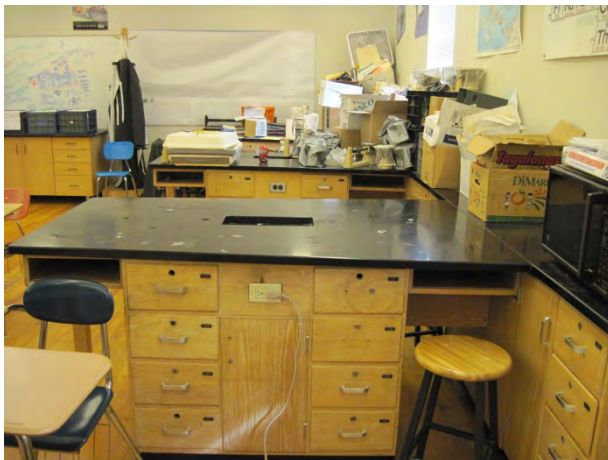
Science rooms need upgrading with new labs, vented fume hood, chemical storage, and improved science prep area. Many of the science labs do not have working fixtures, water faucet, air & gas connections. Lab casework is old drawer locks are missing, door and drawer handles are broken or missing, electrical outlets do not meet current code for GFI protection, and acid resistant tops need upgrading. The student lab configuration of peninsula style casework does not provide the flexibility desired in modern science rooms. (Pictures are of room 212)

The lab above no longer has water faucet or gas and air connections. Of the 6 student labs in the classroom only 2 had working fixtures.

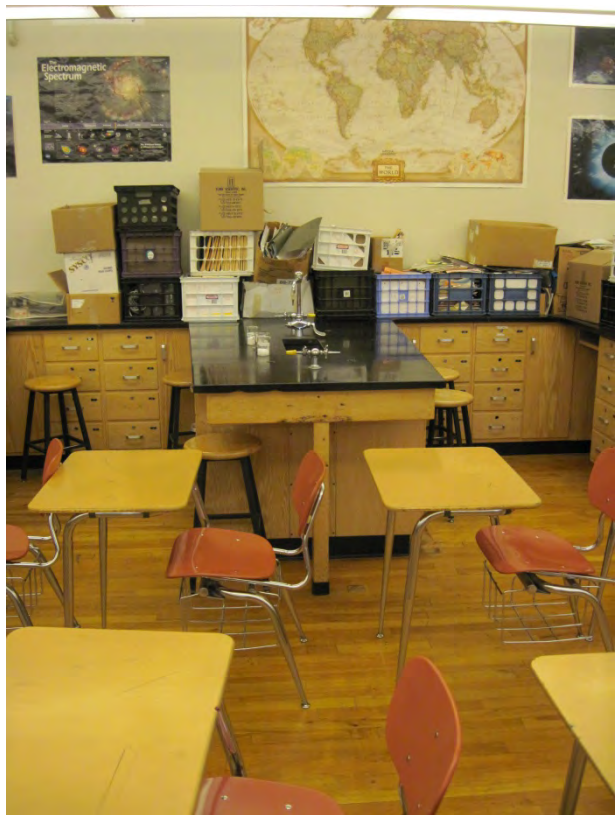
Storage is inadequate and should be considered a hazard both fire and occupant safety.

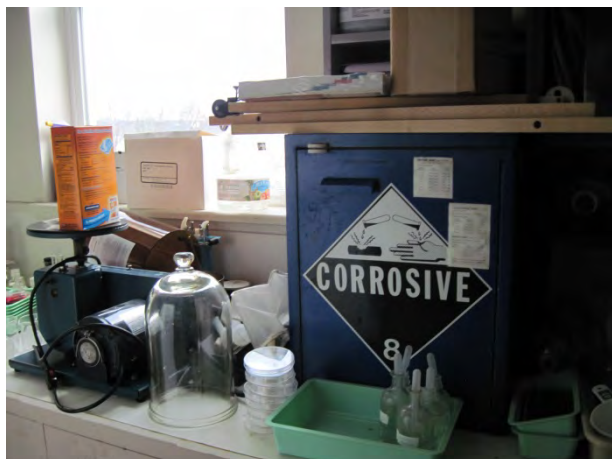
Science prep room storage is inadequate. Chemical storage cabinets are not rated. It is recommended to have a person familiar with the chemical stored to survey age, volatility, and grouping of chemicals in cabinets to determine proper storage and whether chemicals are beyond their allowable shelf life. The teaching wall, room 212, needs upgrading, new storage cabinets, marker board, and teaching lab would make noticeable improvements to the space.

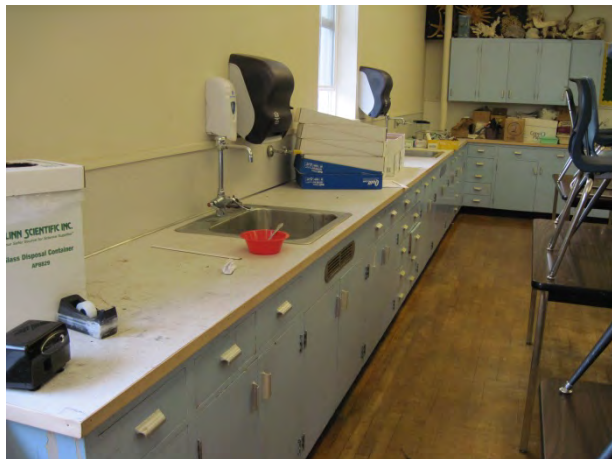
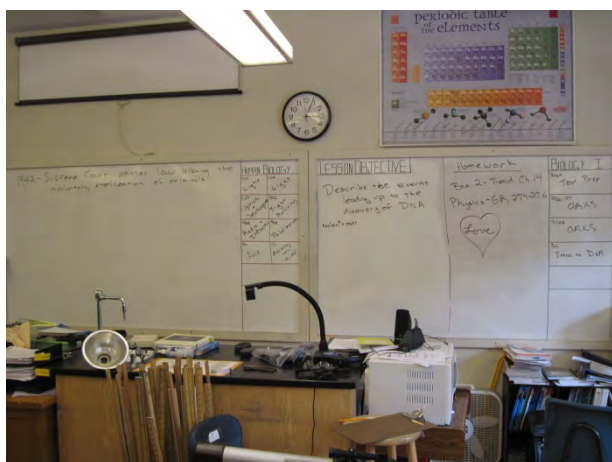
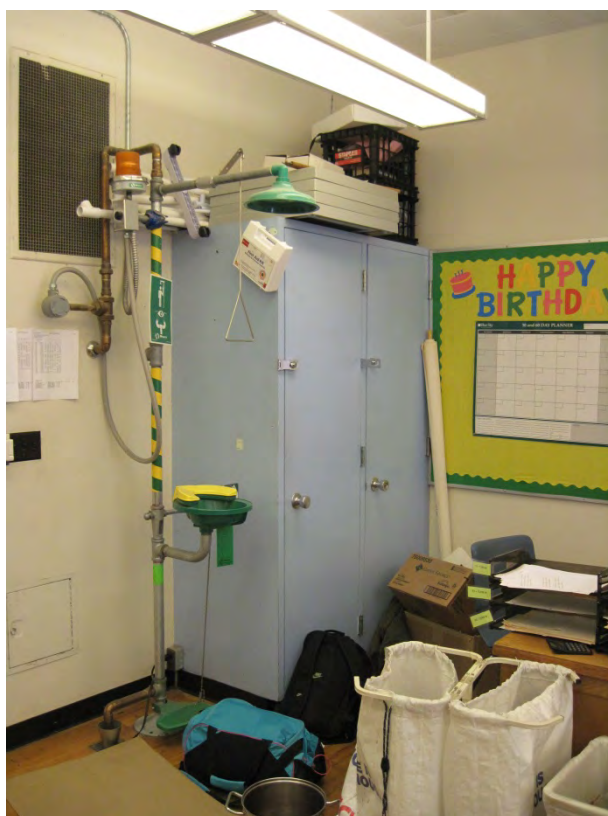
Earth Science room 210, countertops and casework are in poor condition and not constructed out of materials typically used in science classrooms. The teaching wall, teacher's lab needs upgrading. Classroom does have whiteboards although the porcelain finish is at end of life. Storage is inadequate needs significant upgrading allowing for science materials to be stored away.

Both science classrooms share one chemical shower housed in room 210. Installation of another emergency shower in room 212, providing immediate adjacency to the space is recommended.

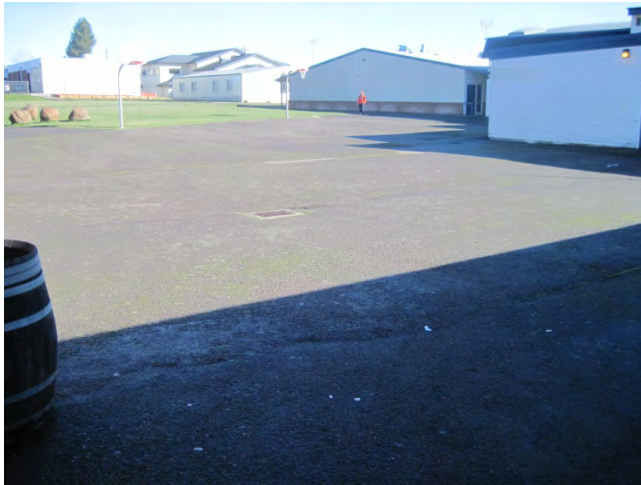
Intermediate School – Area-A, Northwest Play Area; Note, excessive surface wear, cracking, and minor base failure.

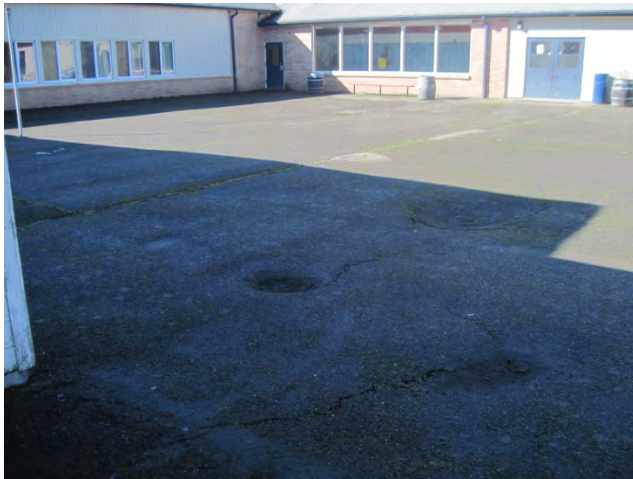
Intermediate School – Area-A, Northwest Play Area; Note, excessive surface wear, cracking, and minor base failure.

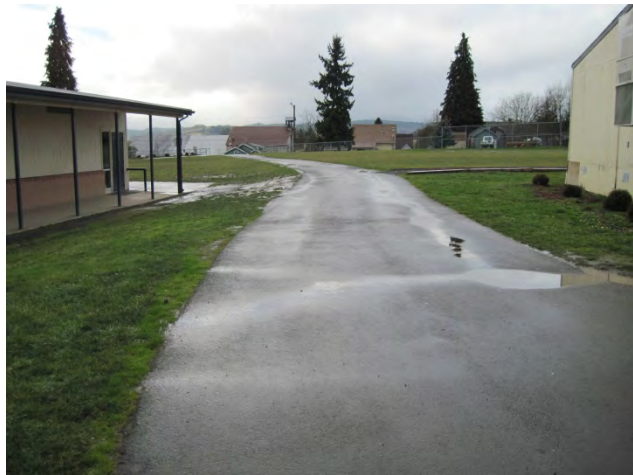
Intermediate School – Area-A, North Field Driveway Area; Note, excessive base failure due to large truck traffic.

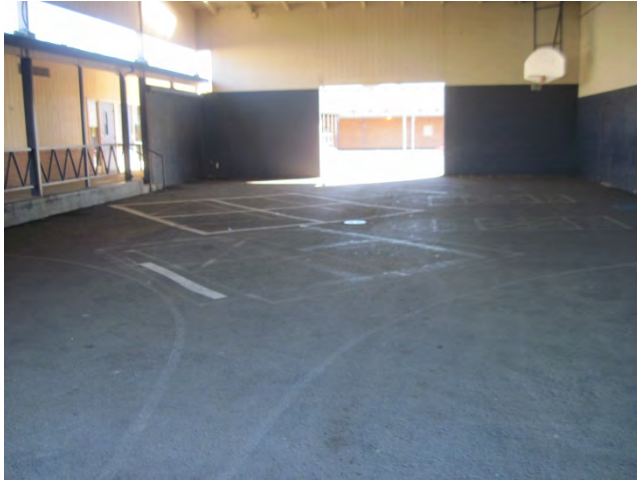
Intermediate School – Area-B, Northwest Covered Play Area; Note, this area is in good condition with the need for only surface cleaning, sealing, and new striping.

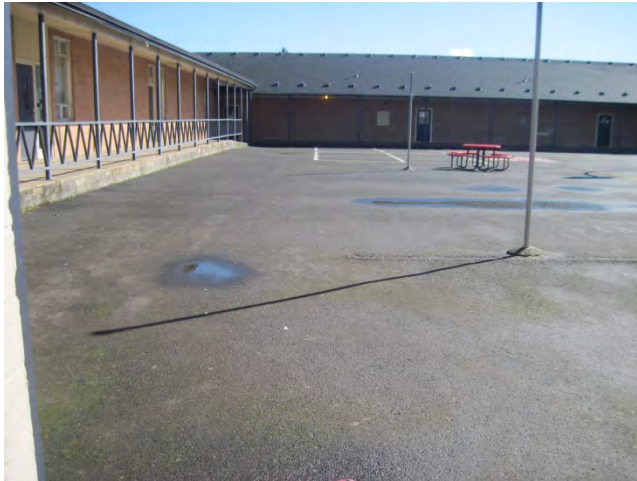
Intermediate School – Area-B, Northwest Courtyard Play Area; Note, this area is in good condition with the need for only surface cleaning, sealing, and new striping.

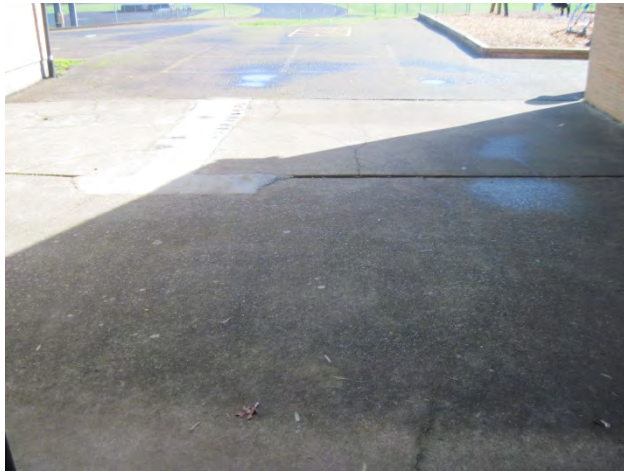
Intermediate School – Area-C, Northeast Play Area; Note, this area is in fair condition with the need for mostly surface cleaning, sealing, and new striping.

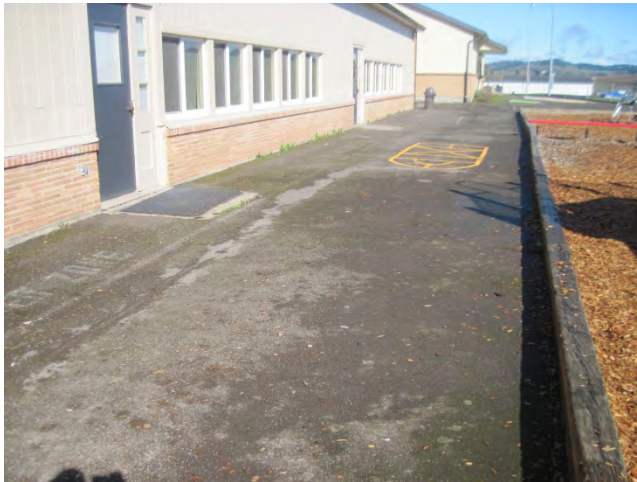
Intermediate School – Area-C, Northeast Play Area; Note, this area is in fair to poor condition with the need for crack and minor base repair, overlay, and new striping.

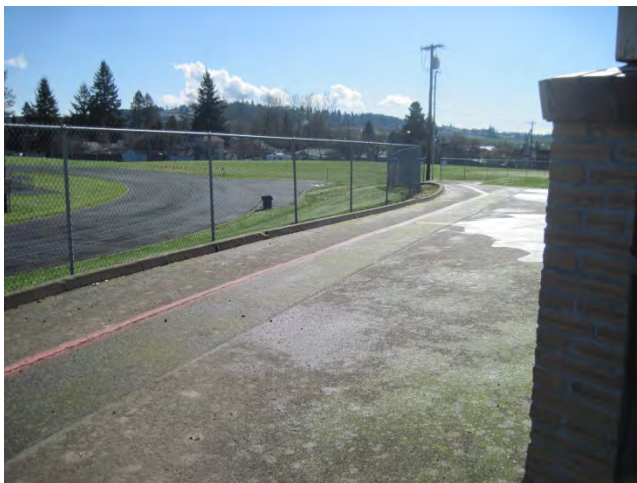
Intermediate School – Area-C, Northeast Perimeter Driveway; Note, this area is in poor condition with the need for crack and base repair, overlay, and new striping.

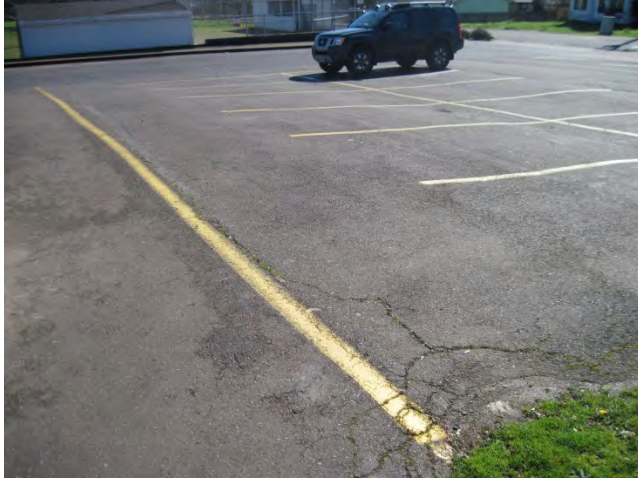
Intermediate School – Area-D, Southeast Parking Lot Area; Note, this area is in fair to poor condition with the need for selective removal and replacement due to the failure of the base rock and surface asphalt. In addition it is showing signs of excessive wear and lacking proper wheel stops.

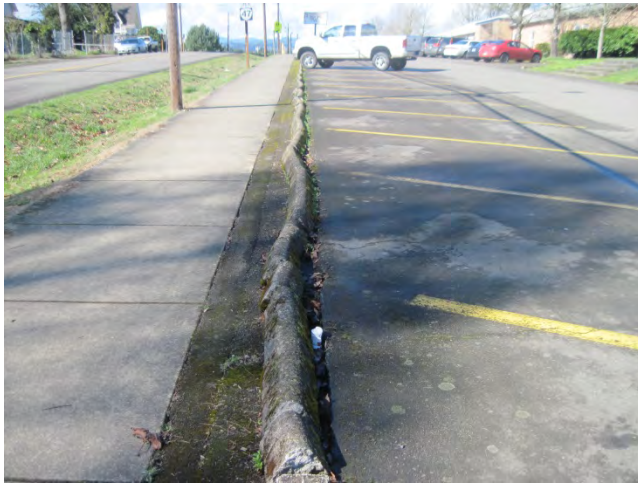
Intermediate School – Area-D, South Parking Lot Area; Note, this area is in fair to poor condition with the need for complete removal and replacement of some areas due to the failure of the base rock and surface asphalt. In addition, the curbing is showing signs of severe degradation and damage over time.

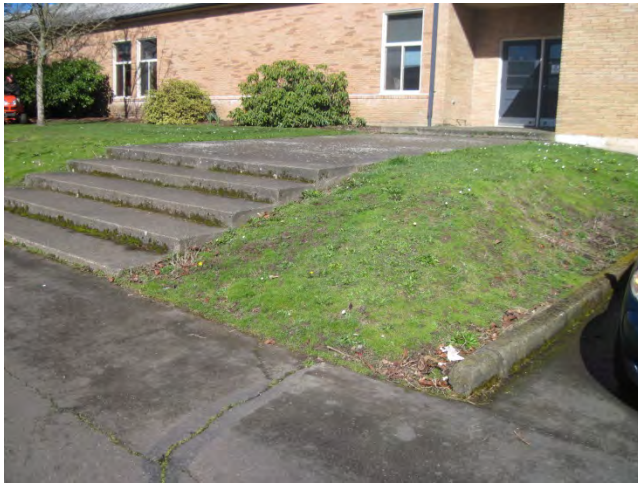
Intermediate School – Area-D, South Parking Lot Entry Area; Note, this area is in poor condition with the need for complete removal and replacement of some areas due to the failure of the base rock and surface asphalt. In addition, the curbing and stairway are showing signs of severe degradation and damage over time.

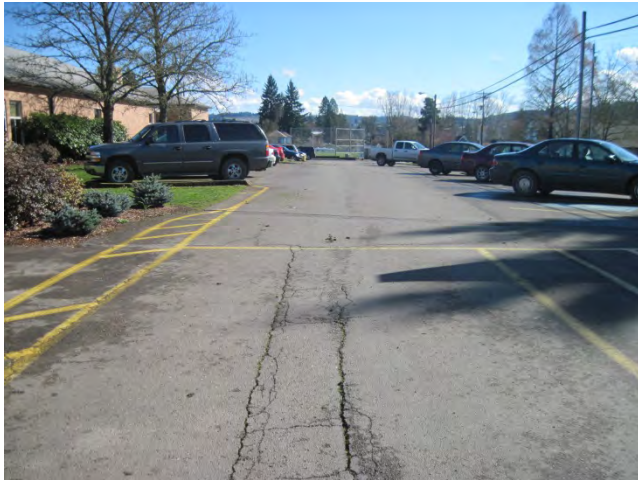
Intermediate School – Area-D, Southwest Parking Lot Area; Note, this area is in poor condition with the need for complete removal and replacement of some areas due to excessive cracking and the failure of the base rock and surface asphalt.

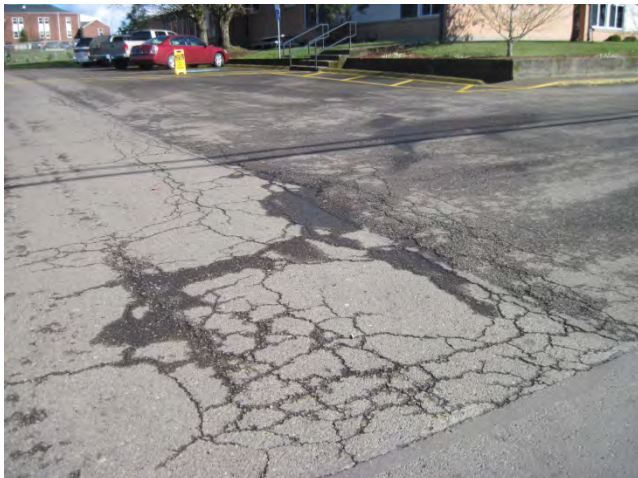
Intermediate School – Area-D, Southwest Parking Lot Area; Note, this area is in very poor condition with the need for complete removal and replacement of most areas due to excessive cracking and the failure of the base rock and surface asphalt.

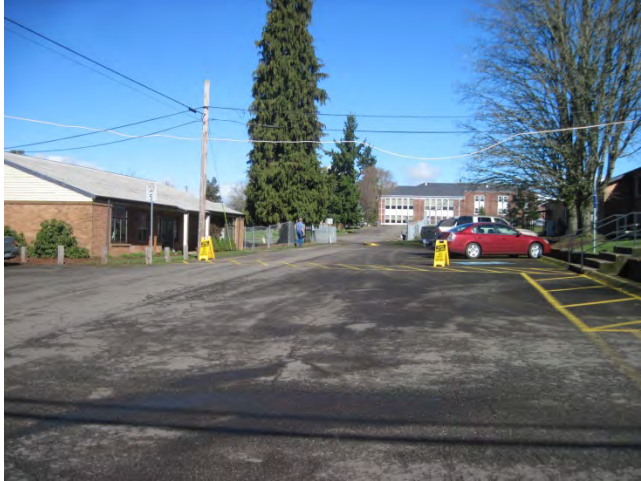
Intermediate School – Area-E, Southwest Parking Lot Area; Note, excessive surface cracking, and base failure.

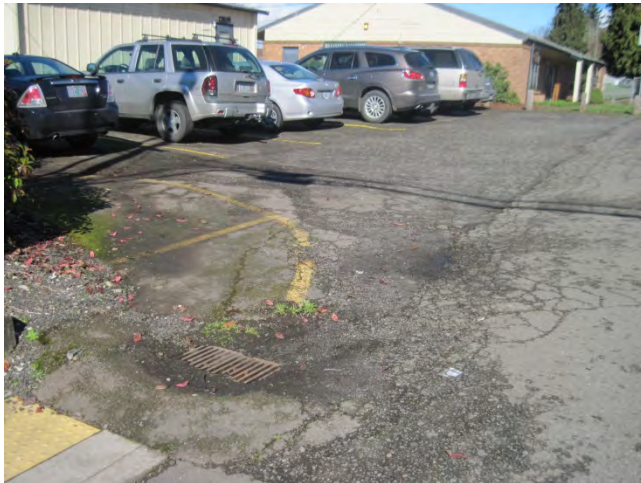
Intermediate School – Area-E, Southwest Modular Parking Lot Area; Note, excessive surface cracking, and base failure. In addition, this area indicates a lack of proper curbing, and drainage.

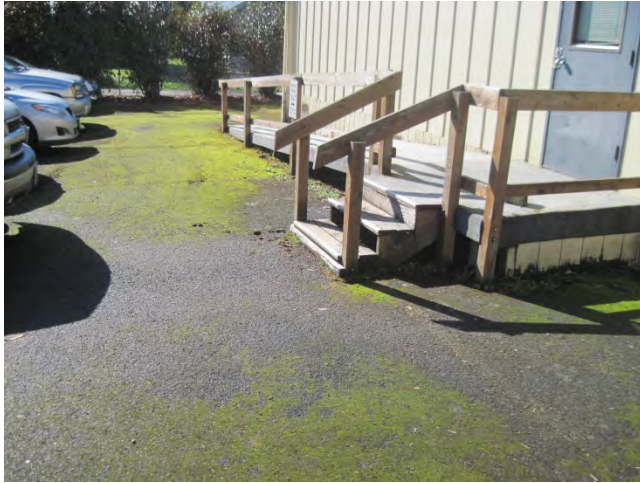
Intermediate School – Area-E, Southwest Modular Parking Lot Area; Note, excessive surface degradation and moss growth. In addition, this area indicates a lack of proper curbing or protective wheel stops and striping.

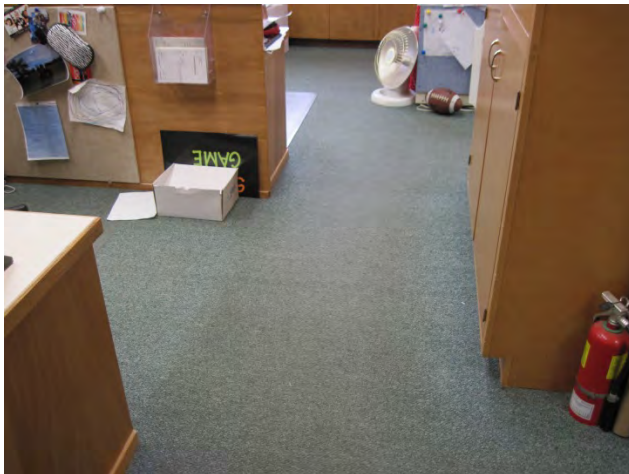
Typical area of worn and outdated carpeting
Second Floor Office Area

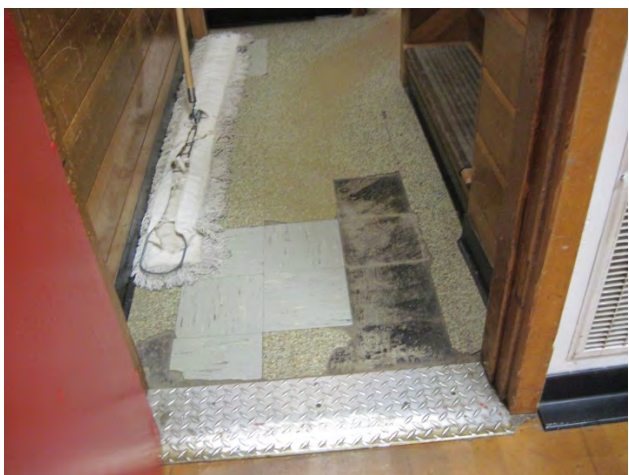
Damaged delaminating 9'x9' asbestos floor tile
Second Floor Locker Rm. Entry

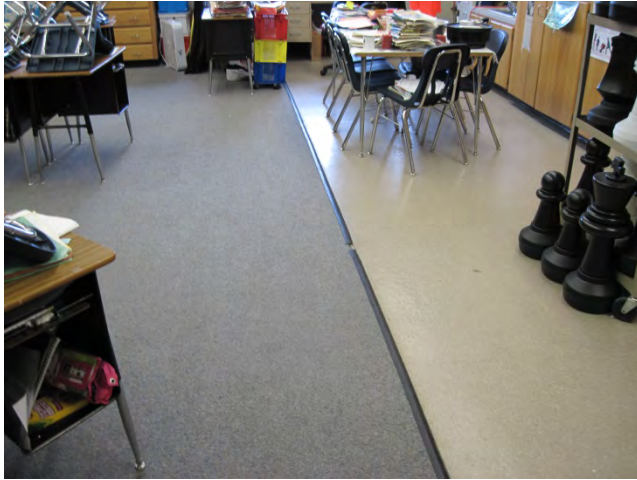
Older worn carpeting and sheet vinyl, Typical -
First Floor Classroom

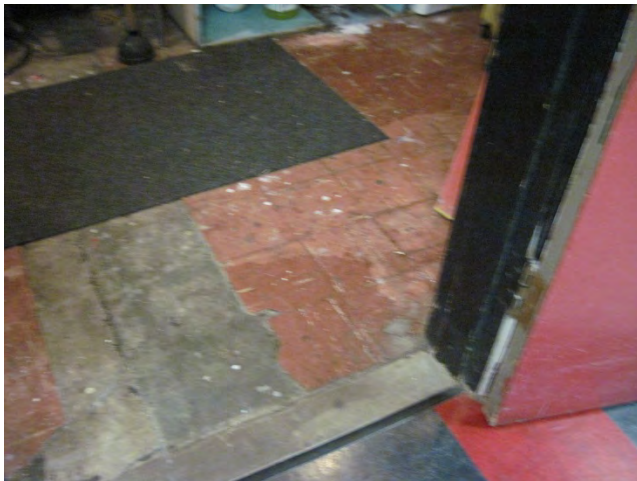
Damaged delaminating 9'x9' asbestos floor tile
Second Floor Custodial Rm.

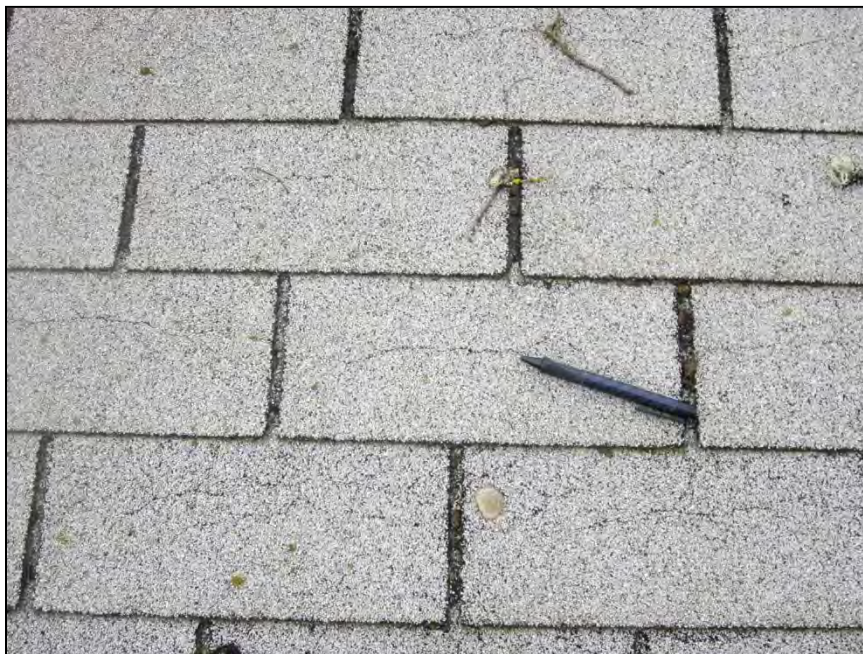
Sec. 1.04 – Roof A: View of typical shingle cracking in the roof field.

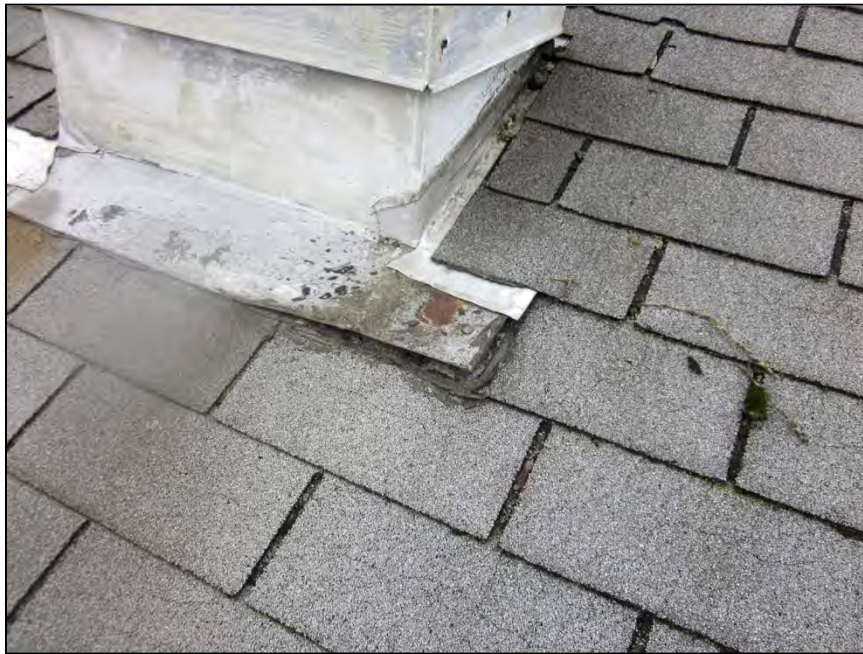
Sec. 1.05 – Roof A: View of typical nails backing out at vent flashing.

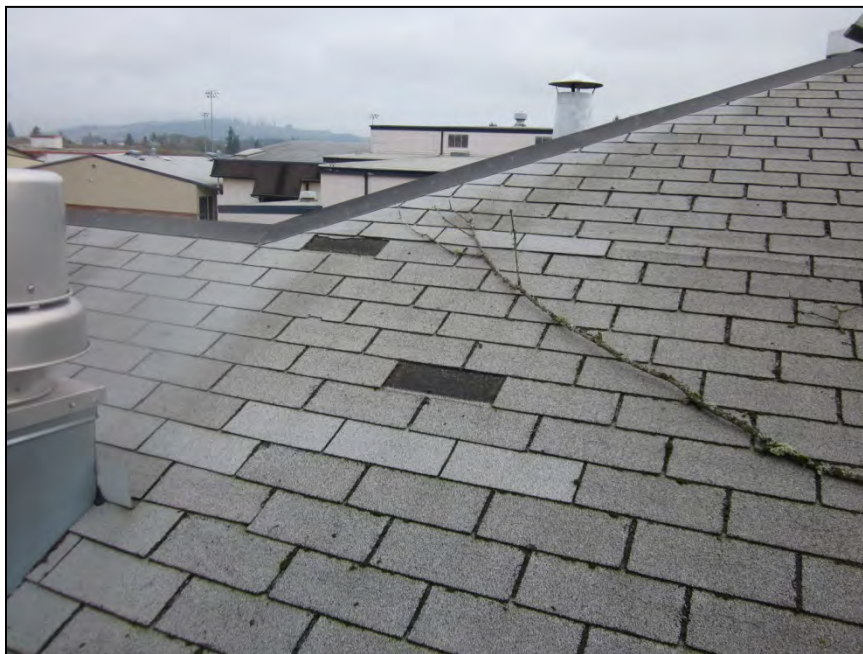
Sec. 1.06 – Roof A: View of missing shingles at west section of the roof.

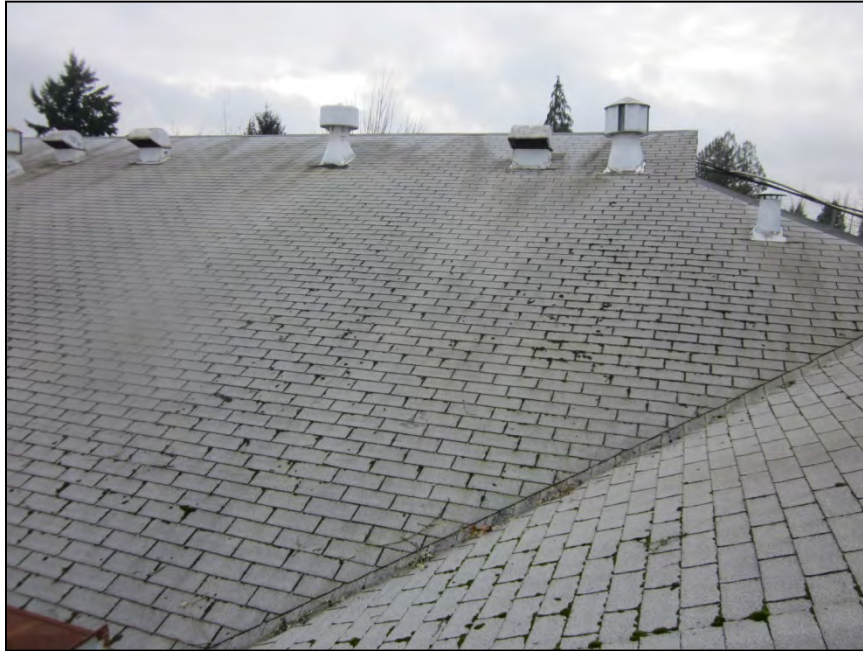
Sec. 1.07 – Roof A: View of typical moss at north section of the roof.

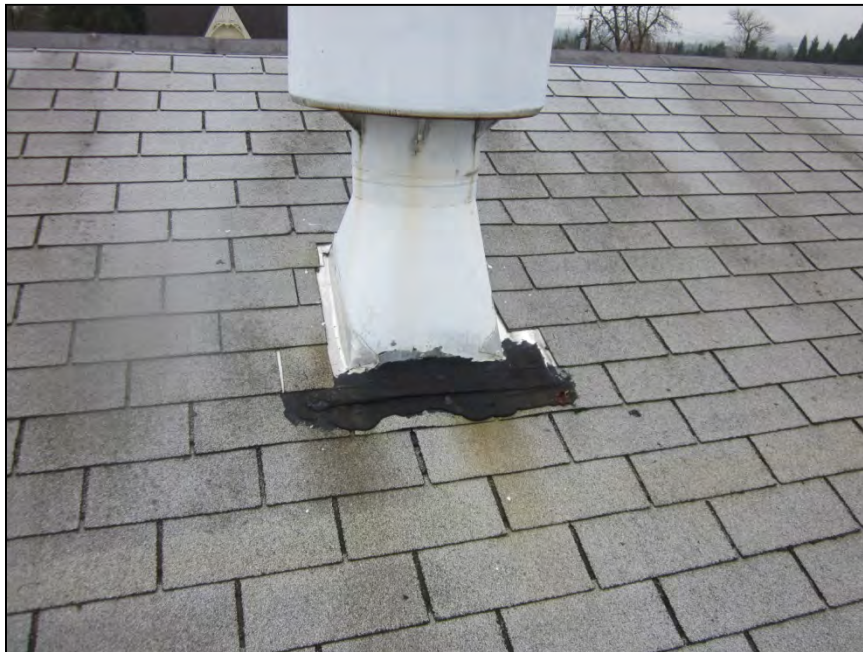
Sec. 1.08 – Roof A: View of typical mastic repair at vent at northwest section of the roof.

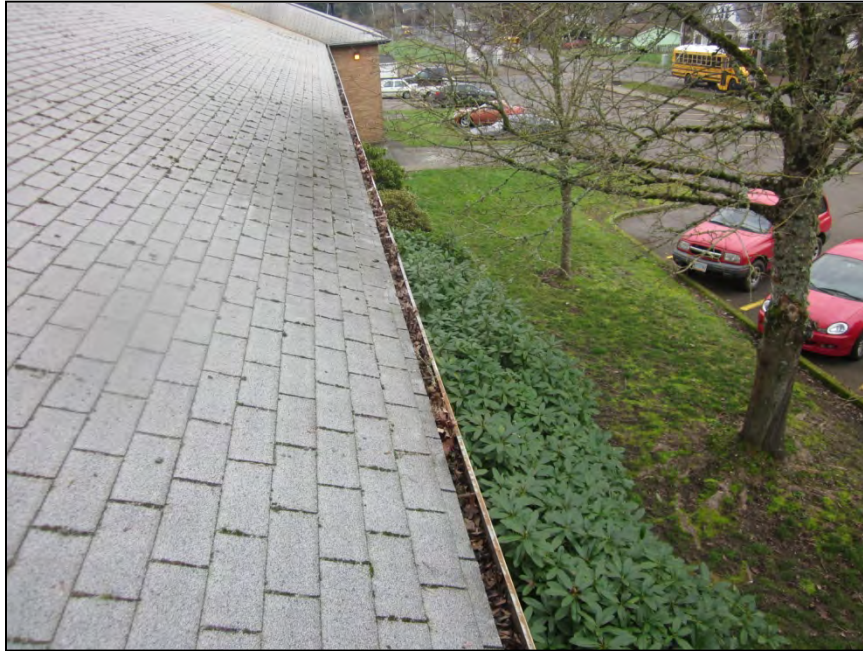
Sec. 1.09 – Roof A: View of organic debris restricting water flow at the south gutter.

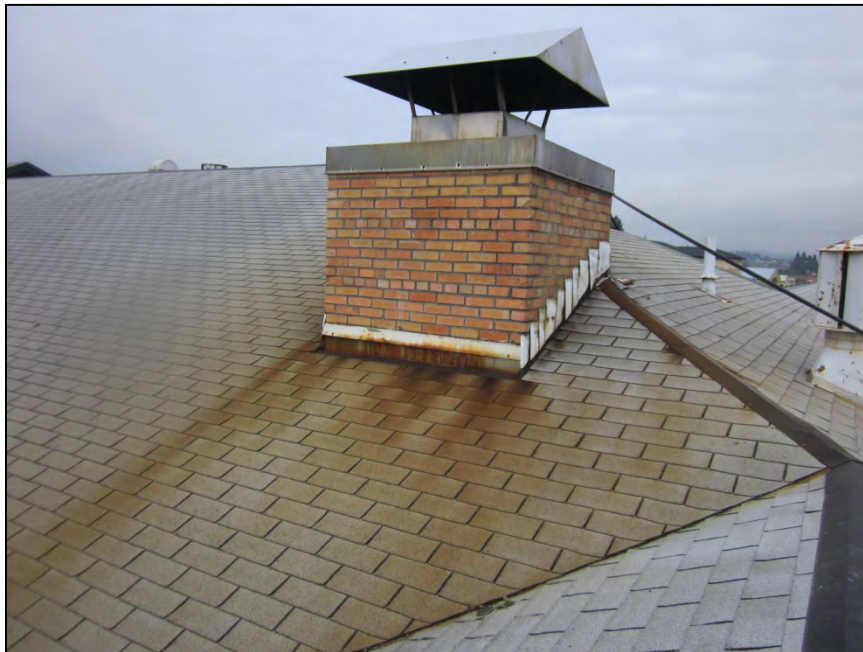
Sec. 1.10 – Roof A: View of shingle staining at chimney at southeast section of the roof.

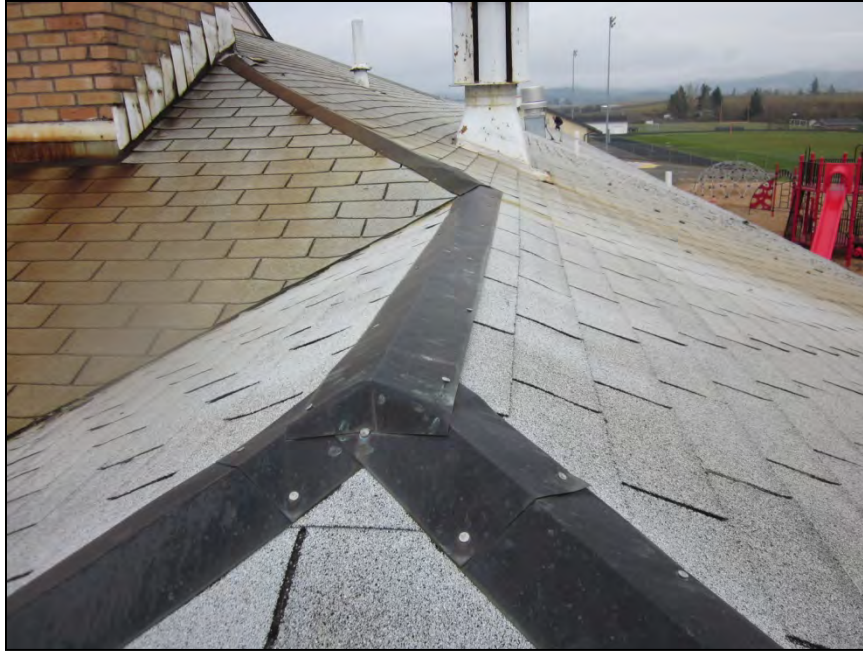
Sec. 1.11 – Roof A: View of nails backing out at metal flashing at southeast section of the roof.

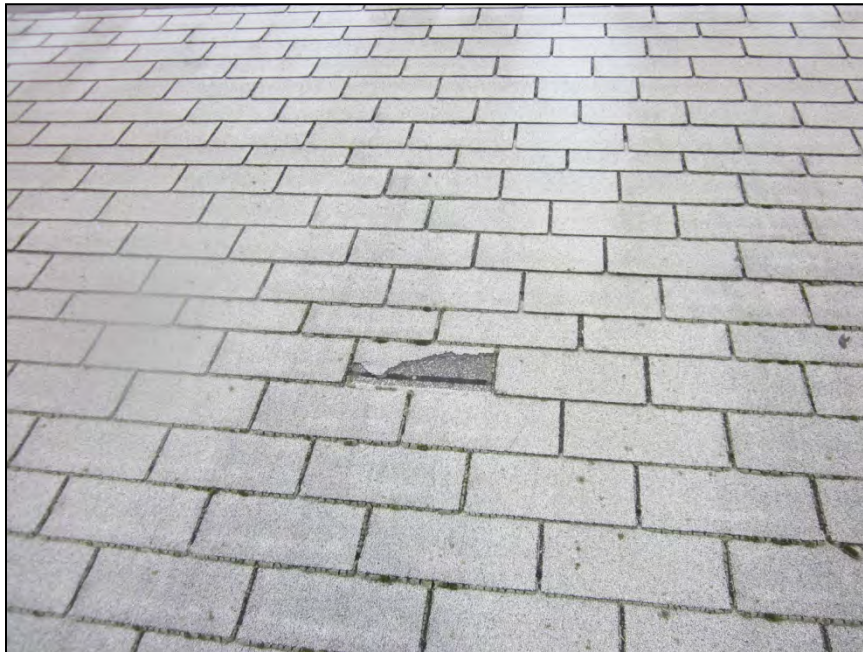
Sec. 1.12 – Roof A: View of damaged shingle at northeast section of the roof.

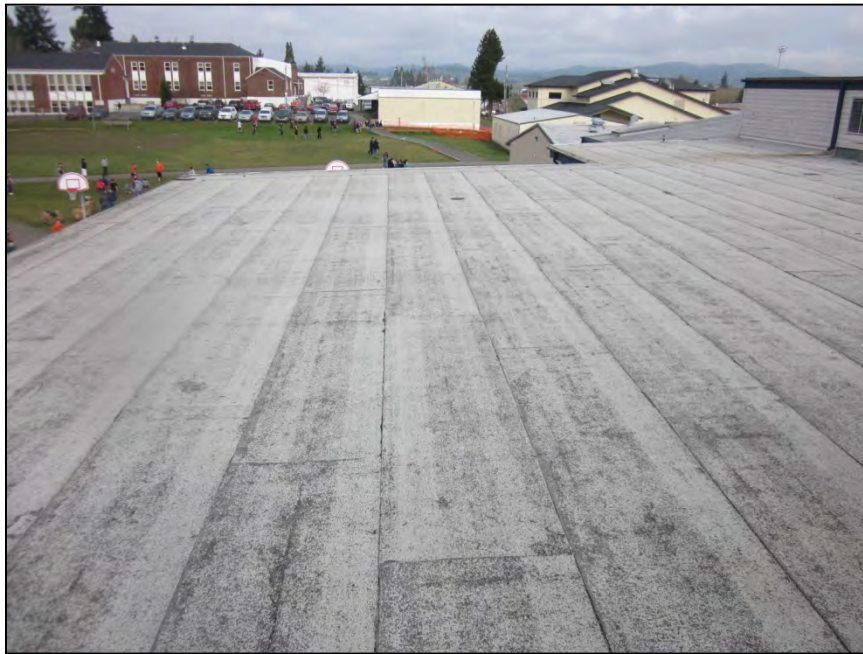
Sec. 1.13 – Roof B: View to north across the roof field. Note cap sheet deterioration.

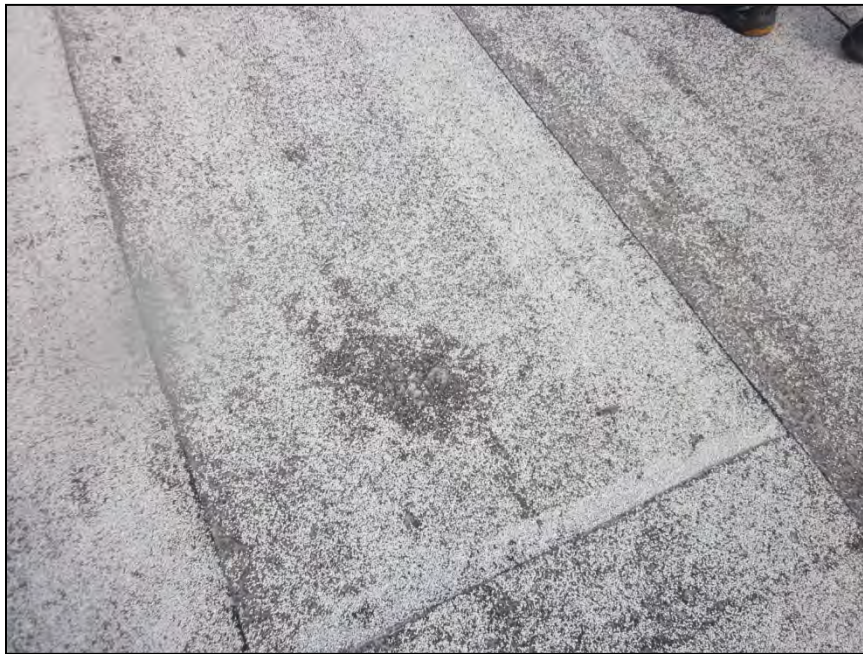
Sec. 1.14 – Roof B: View of fiberglass showing thru cap sheet at west section of the roof.

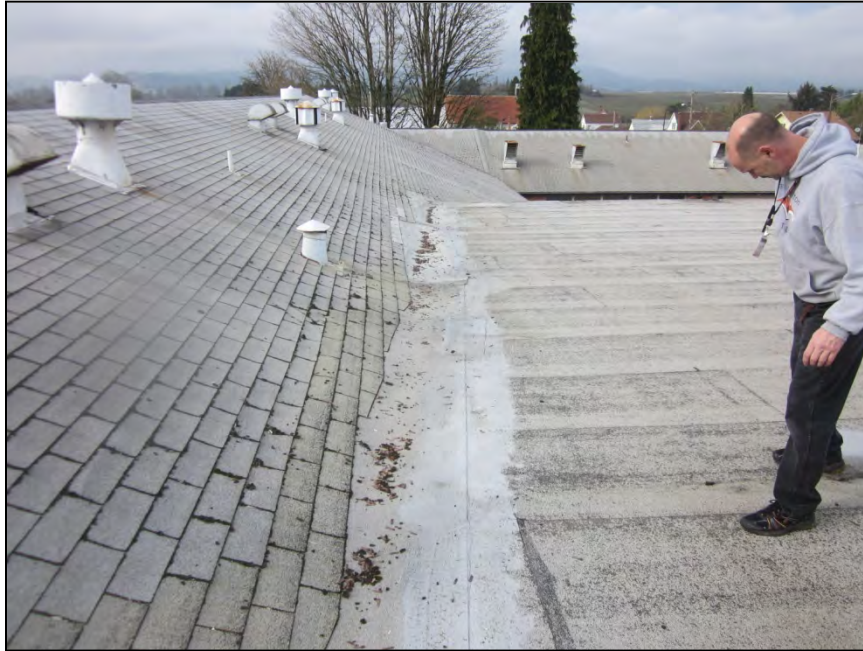
Sec. 1.15 – Roof B: View of previous repairs at tie-in between Roofs B & C.

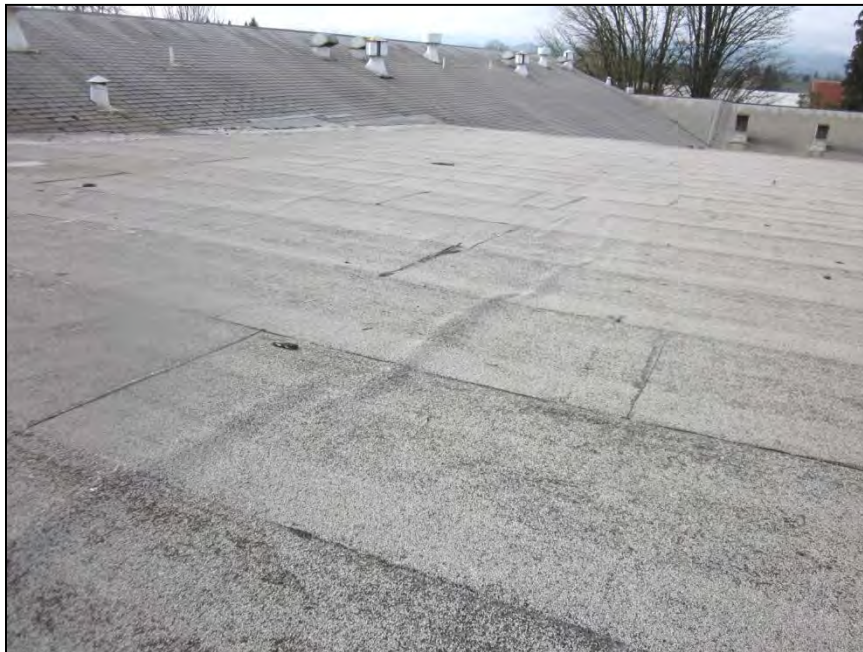
Sec. 1.16 – Roof B: View of cap sheet ridging in the roof field.

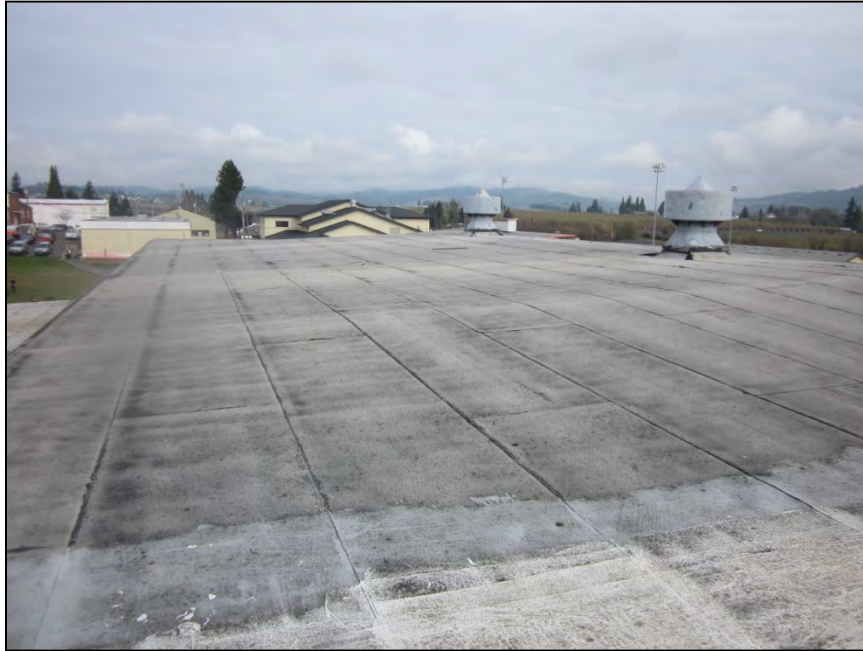
Sec. 1.19 – Roof D: View to north across the roof field. Note cap sheet deterioration.
