Yamhill-Carlton School District

Building Assessment

Yamhill Carlton Intermediate School

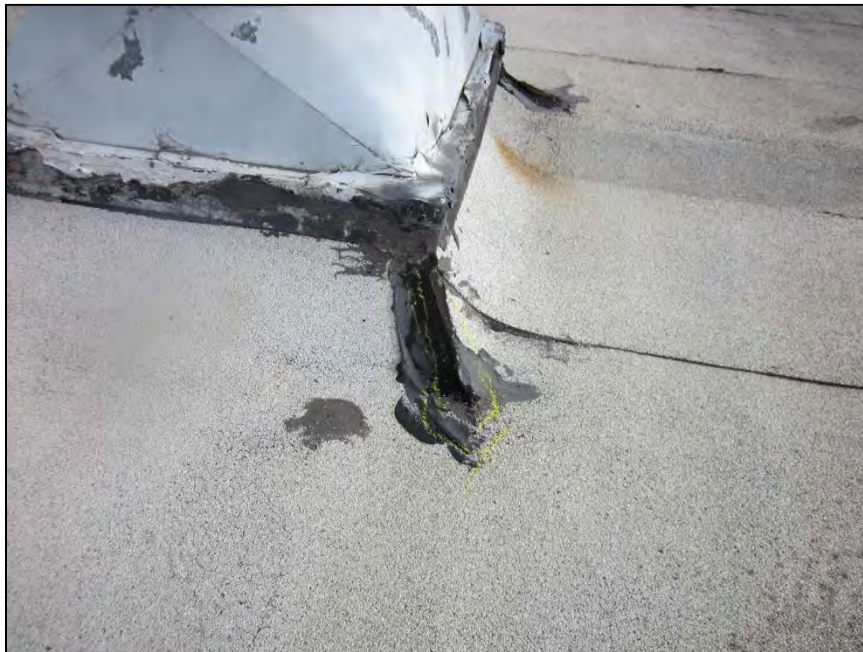
Sec. 1.20 – Roof D: View of typical void in mastic repair at vent curb.

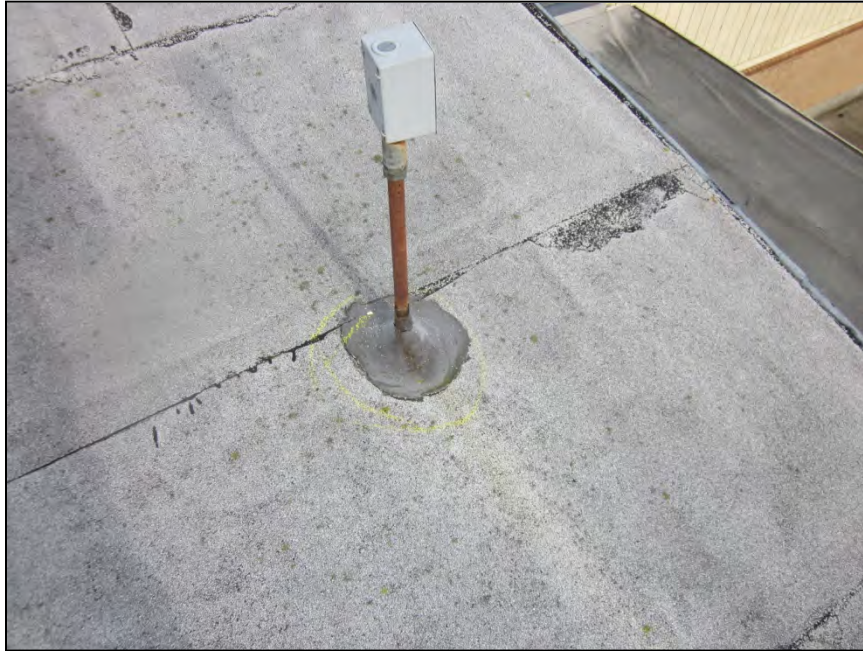
Sec. 1.23 – Roof F: View of typical voids in mastic repair at a pipe penetration.

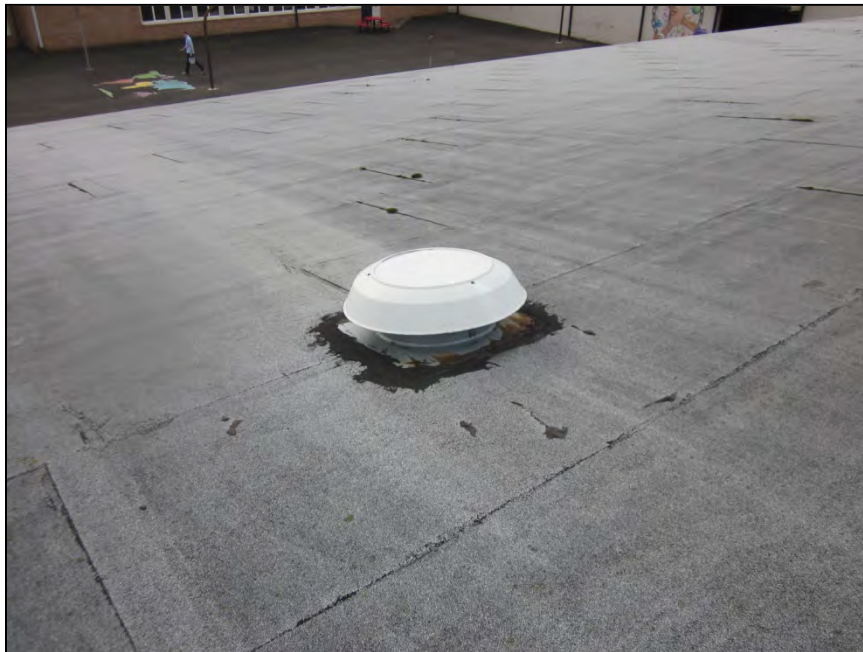
Sec. 1.24 – Roof F: View of typical mastic repair at vent in the roof field.

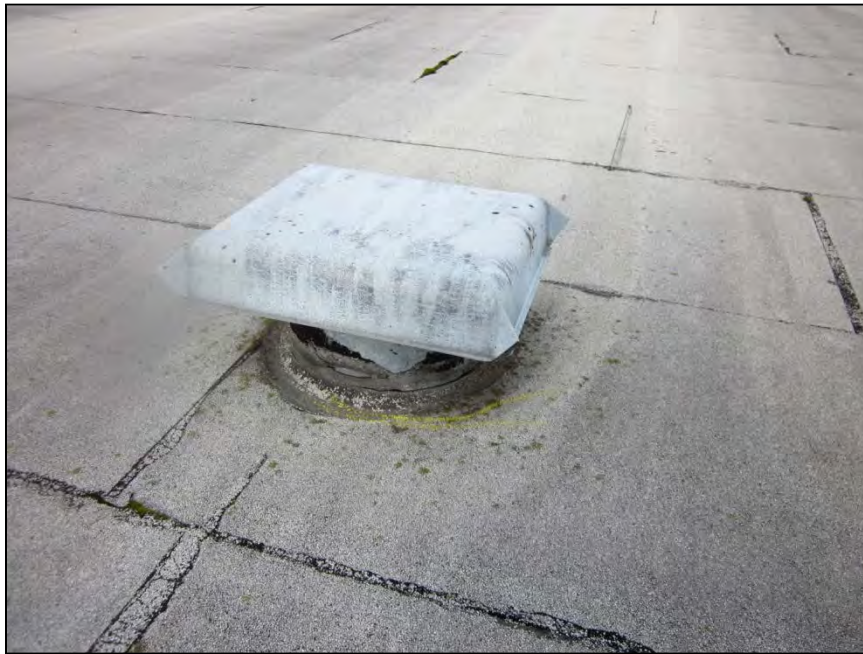
Sec. 1.25 – Roof F: View of typical voids in mastic repair at vent in the roof field.

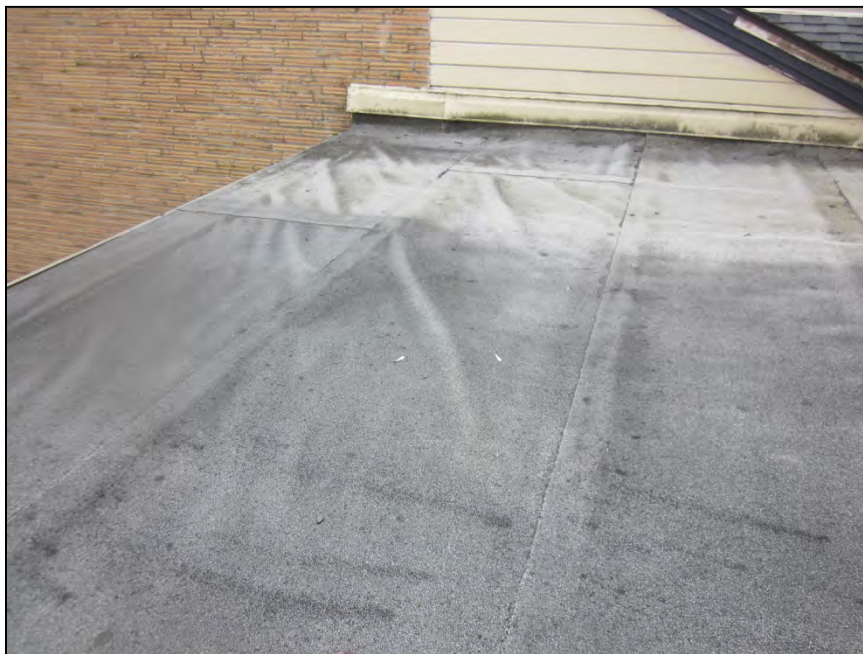
Sec. 1.26 – Roof G: View of ridging in the roof field.

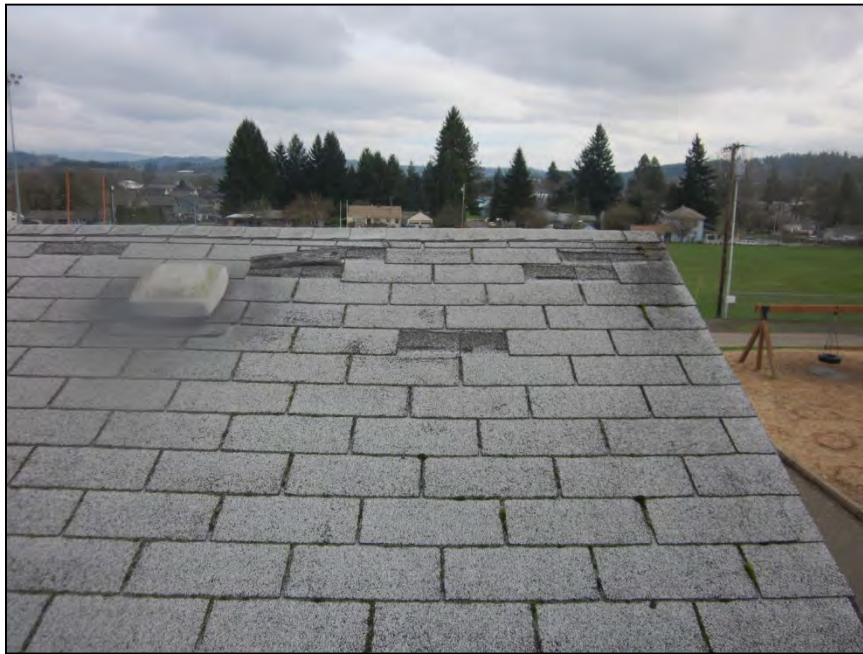
Sec. 1.29 – Roof I: View of missing shingles at southwest section of the roof.
