Yamhill-Carlton School District

Building Assessment

Yamhill Carlton Intermediate School

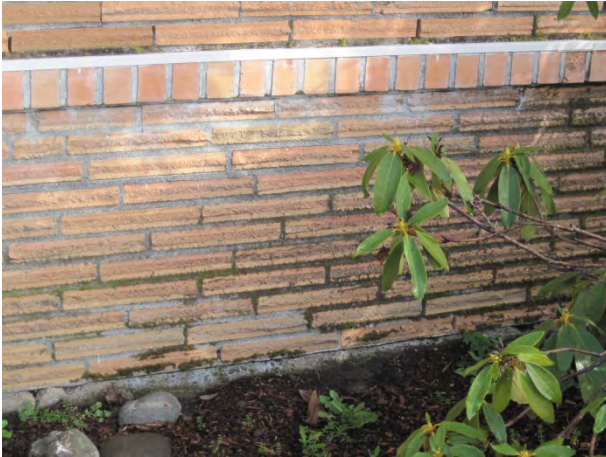
The picture shows moss and growth on south side of building behind shrubs. Mold, moss, and mildew needs to be treated and removed, with brick water repellent applied.

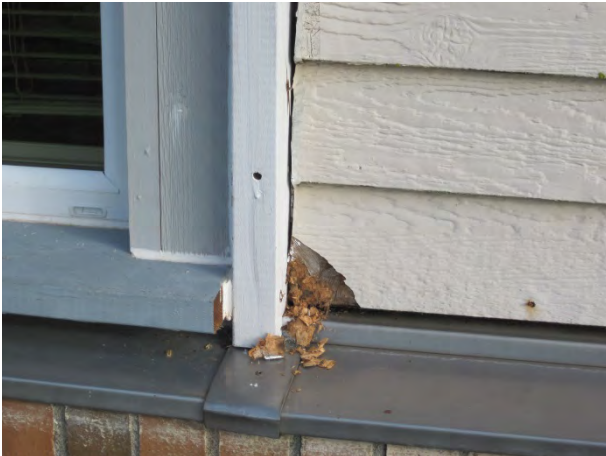
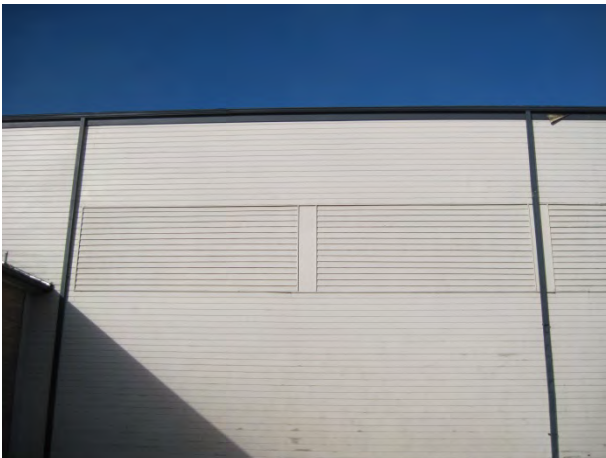
On the South Side of the building as well as on the gym, we observed what appears to be LP Lap Siding. The siding is showing signs of delamination. The district should replace all LP Siding immediately. If funds are not available for immediate replacement the district could apply Elastomeric coating to all exposed edges and surfaces, providing the district with 5 years additional life until the replacement could be budgeted.

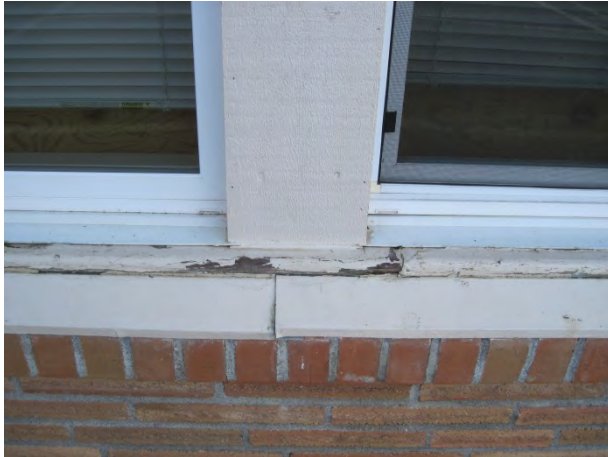
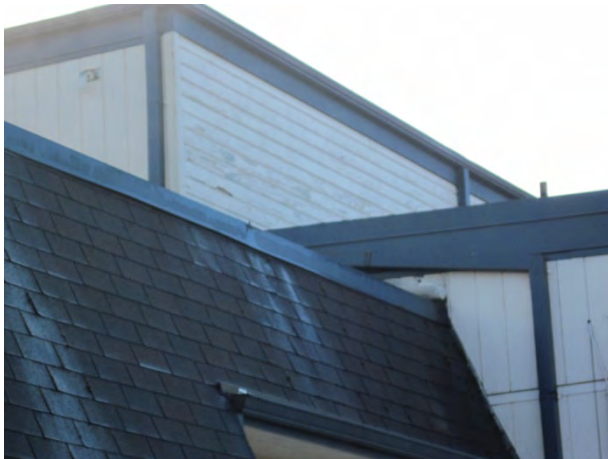
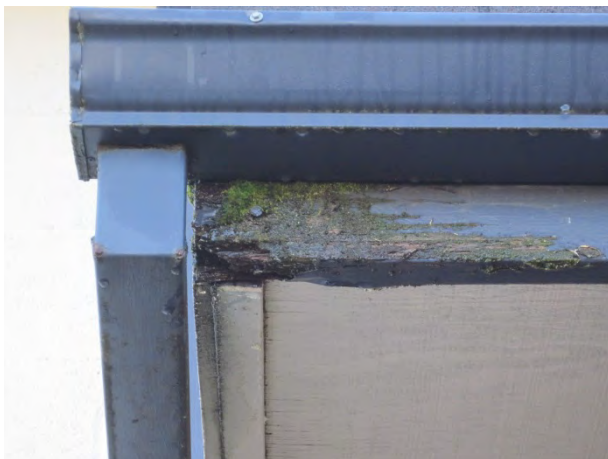
Another area needing attention is exterior paint of all wood siding, trim, and doors. Many areas have peeling paint, missing caulking, and raw wood exposed to the weather. Prolonged exposure of the exterior wood surfaces to the weather will experience dry rot. You will note some of the pictures in this report show various forms of paint degradation. We recommend that the entire building, all wood surfaces, doors, and trim receive paint.

These pictures depict the exterior siding and trim degradation observed around the building.

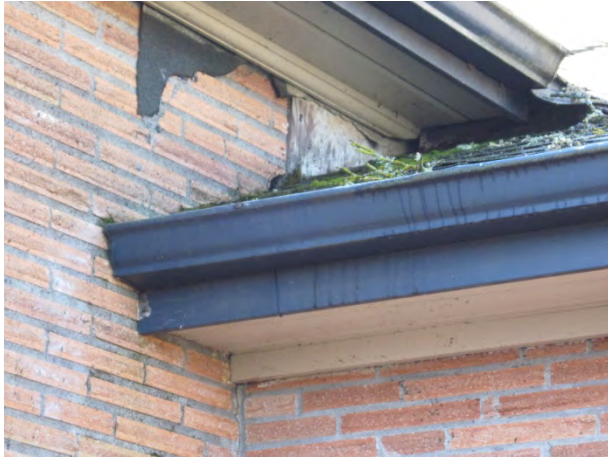
This area is at an overhand where the brick was stopped short

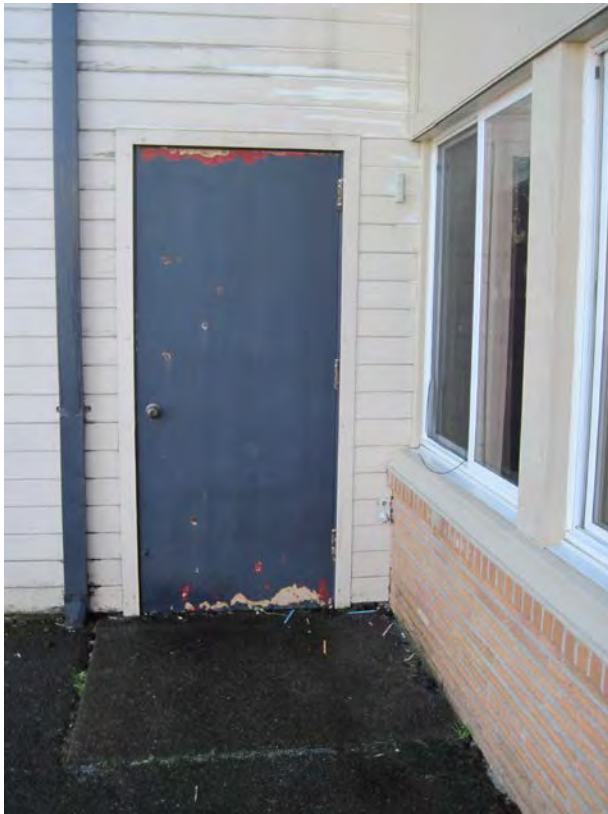
Door to wrestling room no longer opens and closes without using tremendous force.

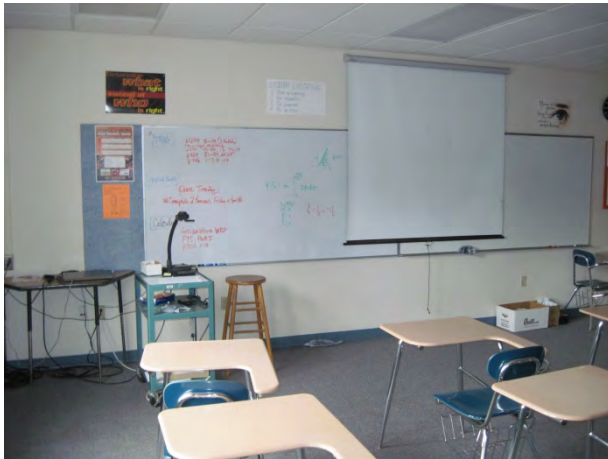
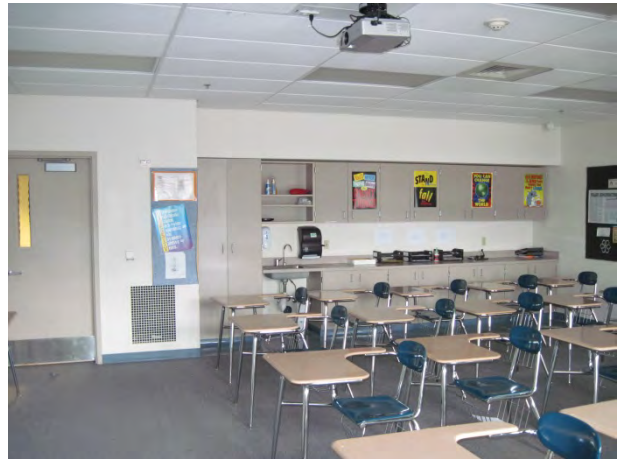
Basement and main floor classrooms do not have adequate storage. Marker boards are inadequate with the porcelain writing surface nearing end of life. Many rooms do not have bulletin boards or have surfaces not made for pinning display materials; teachers use creative ways to display items even when pinnable surfaces are not available. (Pictures below are of room 206)

Contrast the pictures above as a typical basement and main floor classroom with pictures of the 2nd floor classrooms having storage, marker and bulletin board accommodations appropriate to a high school standard.

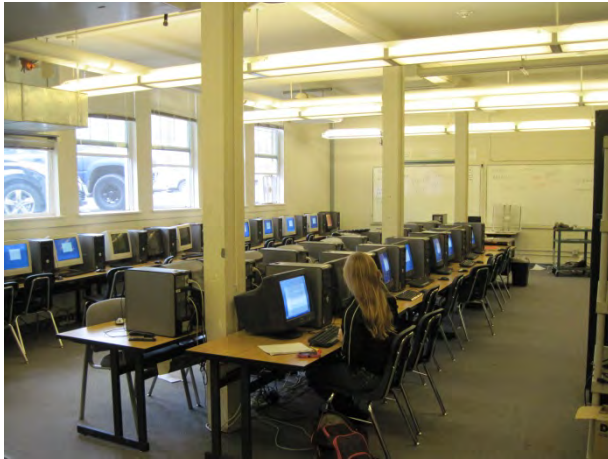
Comfort in the basement computer lab is poor, excessively hot needing additional fans to provide air movement

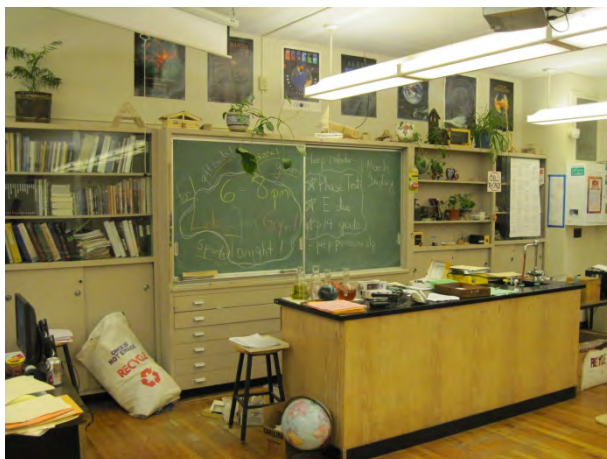
Science prep room storage is inadequate. Chemical storage cabinets are not rated. It is recommended to have a person familiar with the chemical stored to survey age, volatility, and grouping of chemicals in cabinets to determine proper storage and whether chemicals are beyond their allowable shelf life. The teaching wall, room 212, needs upgrading, new storage cabinets, marker board, and teaching lab would make noticeable improvements to the space.

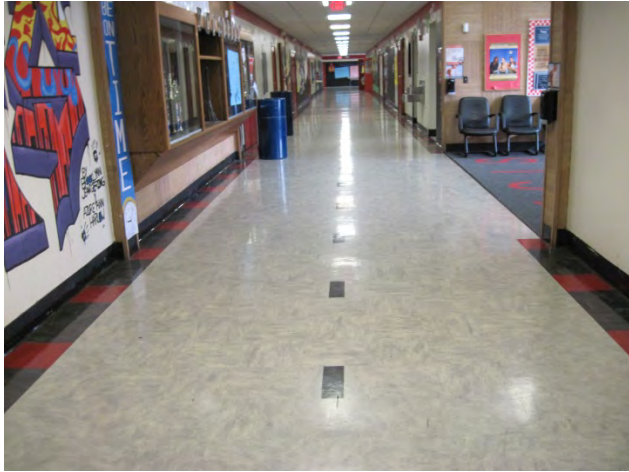
Newer sheet vinyl, Second Floor Corridors

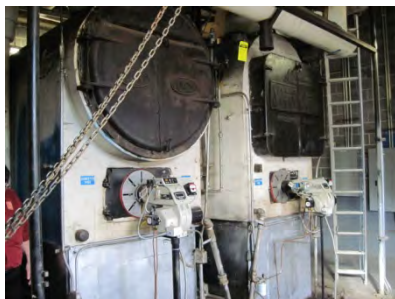
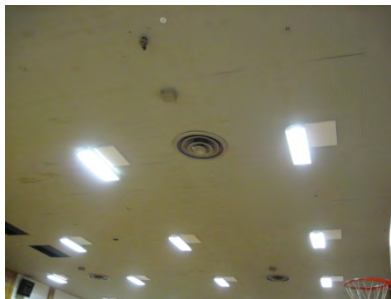
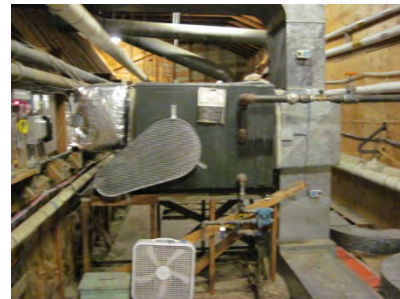
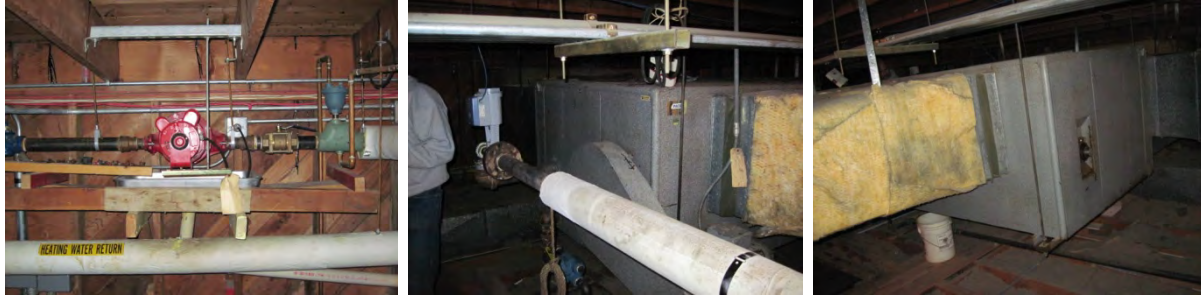
1. The boilers and the steam system infrastructure and piping are old and failure should be anticipated. Many of the leaks recorded by the Facilities department have been “pinhole” leaks in the steam piping.
2. The boiler efficiency is only 78%.
3. The exhaust fans in the restrooms are not operating.
4. The building control system cannot control within specifications.
5. Combustion air to the boiler room does not meet current code requirements.

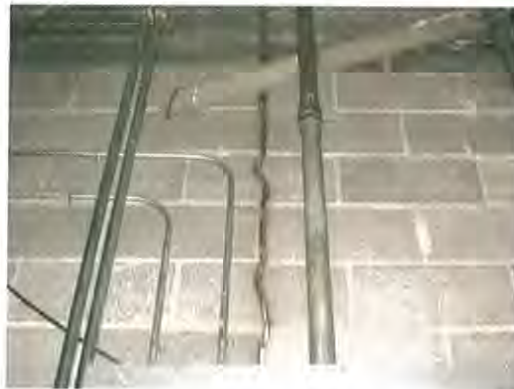
The north CMU wall of the boiler room in the southeast corner of the building has a significant vertical crack. This appears to have been present for quite some time and we could not verify any recent movement. This crack should be monitored, but unless additional movement is detected, no repair is required. The wall finish on the opposite side of the wall has a crack in the finish and should also be monitored. A smaller crack was noted in the south wall of the boiler room concrete wall which is not deemed significant.

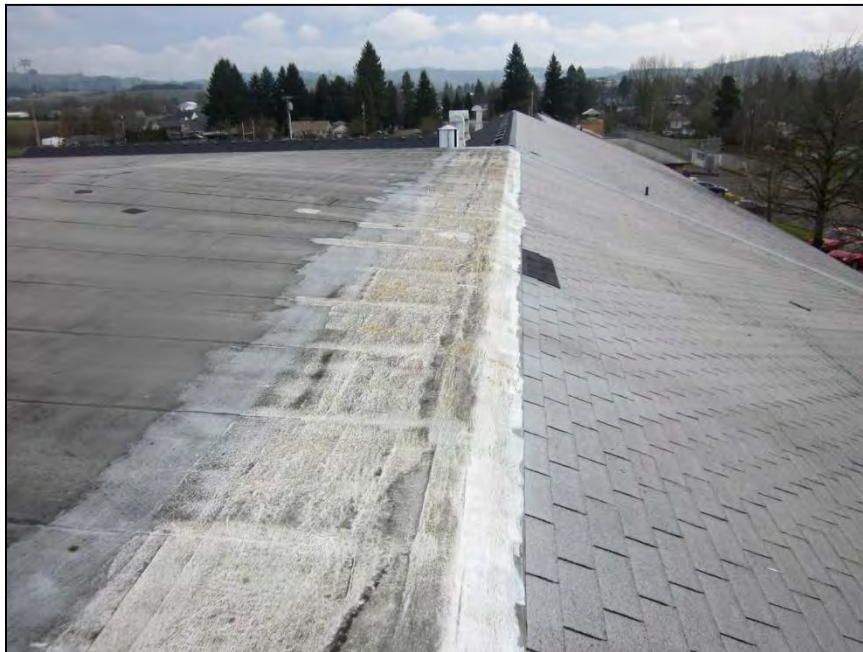
Sec. 1.18 – Roof D: View to east of previous repairs at tie-in between Roofs A & D.

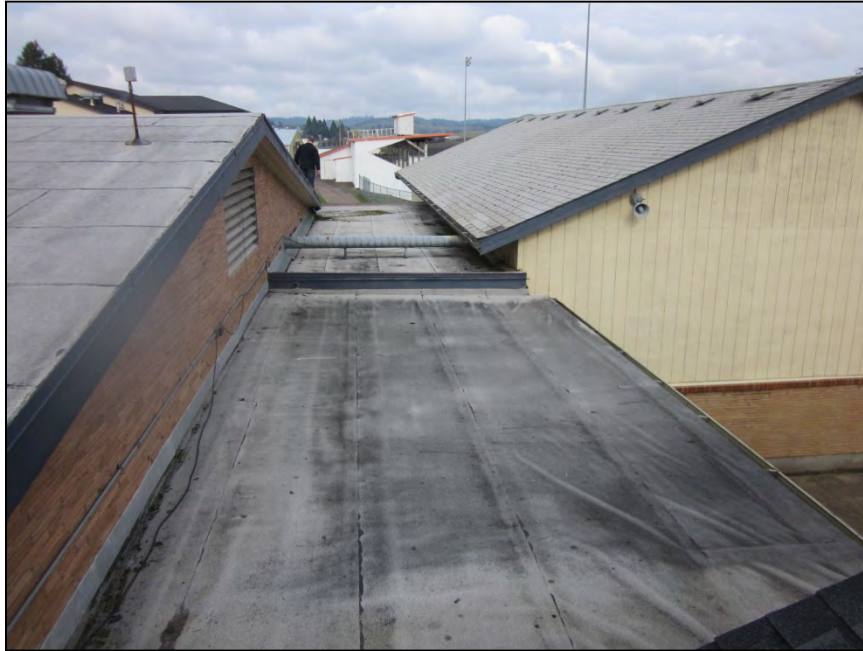
Sec. 1.27 – Roof H: View to north across the roof field. Note cap sheet ridging in the roof field.
